CITY OF HOUSTON

**PUBLIC WORKS AND
ENGINEERING
PLANNING & DEVELOPMENT
DIVISION**

EXECUTIVE SUMMARY

Appendix B – Site Maps

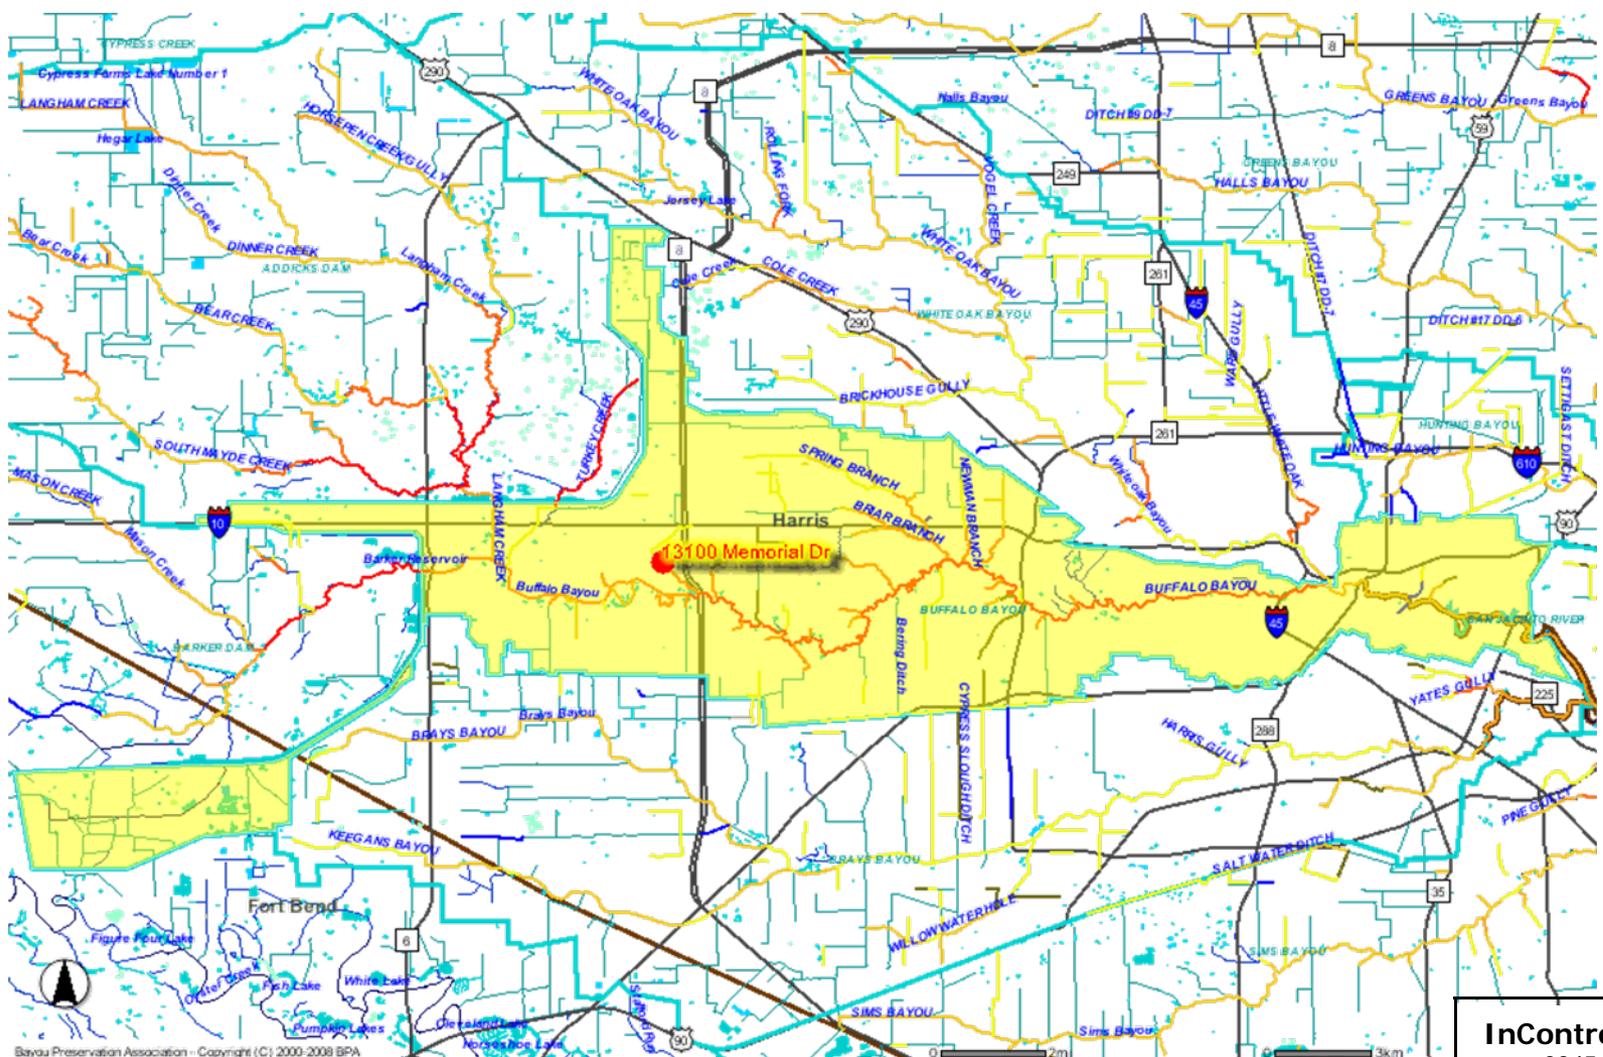
CLIENT:		PM:	
SRS Shopping Centers, Ltd.		JB	
LOCATION:		CHECKED:	
Memorial Drive Houston, Texas			
DETAILED:	DESIGNED:	PROJECT NO.:	FIGURE:
6/25/02	JB		2B

The subject property is located within the Buffalo Bayou watershed (**Figure 2B**). The site is not located in the 100-year floodplain (**Figure 3B**).

Buffalo Bayou Watershed Map

Figure 2B – Watershed Map

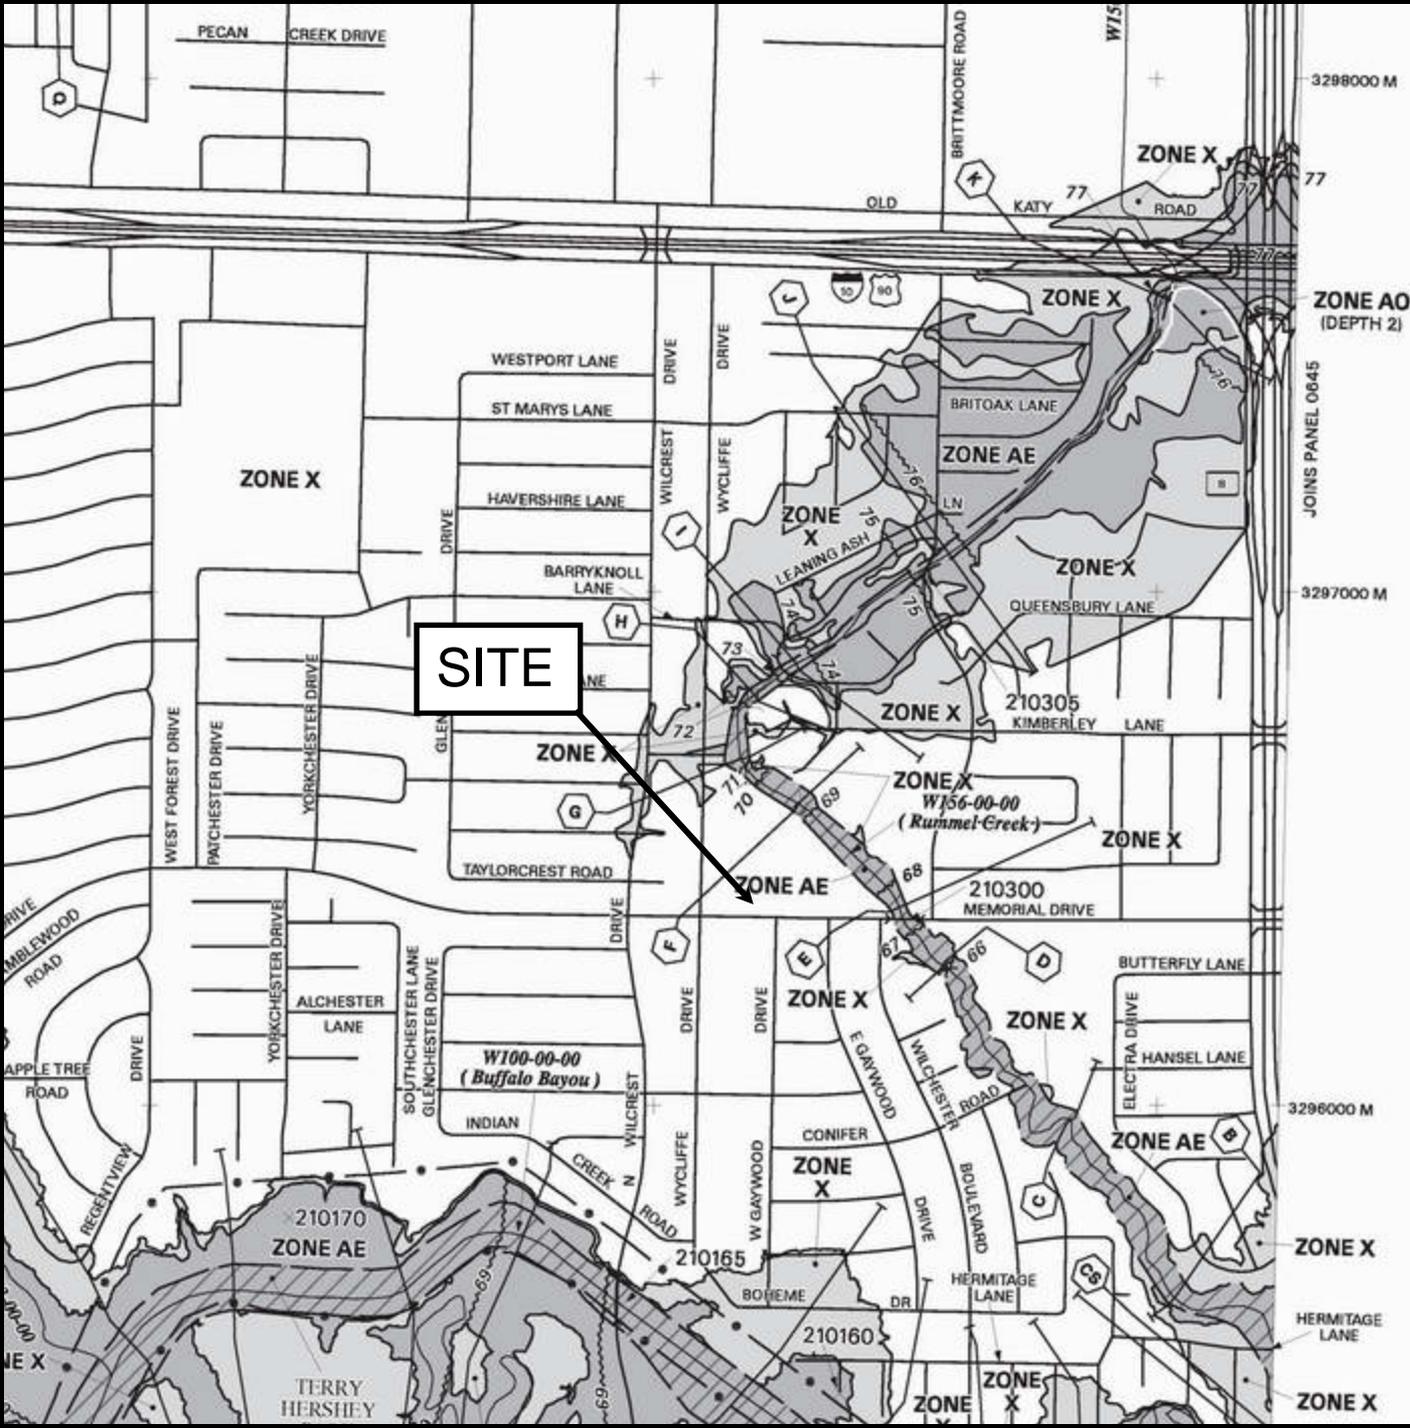
CLIENT:	SRS Shopping Centers, Ltd.	PM:	JB
LOCATION:	Memorial Drive Houston, Texas	CHECKED:	
DETAILED:	6/25/02	DESIGNED:	JB
PROJECT NO.:		FIGURE:	3B

Floodplain Map

Figure 3B – Floodplain Map

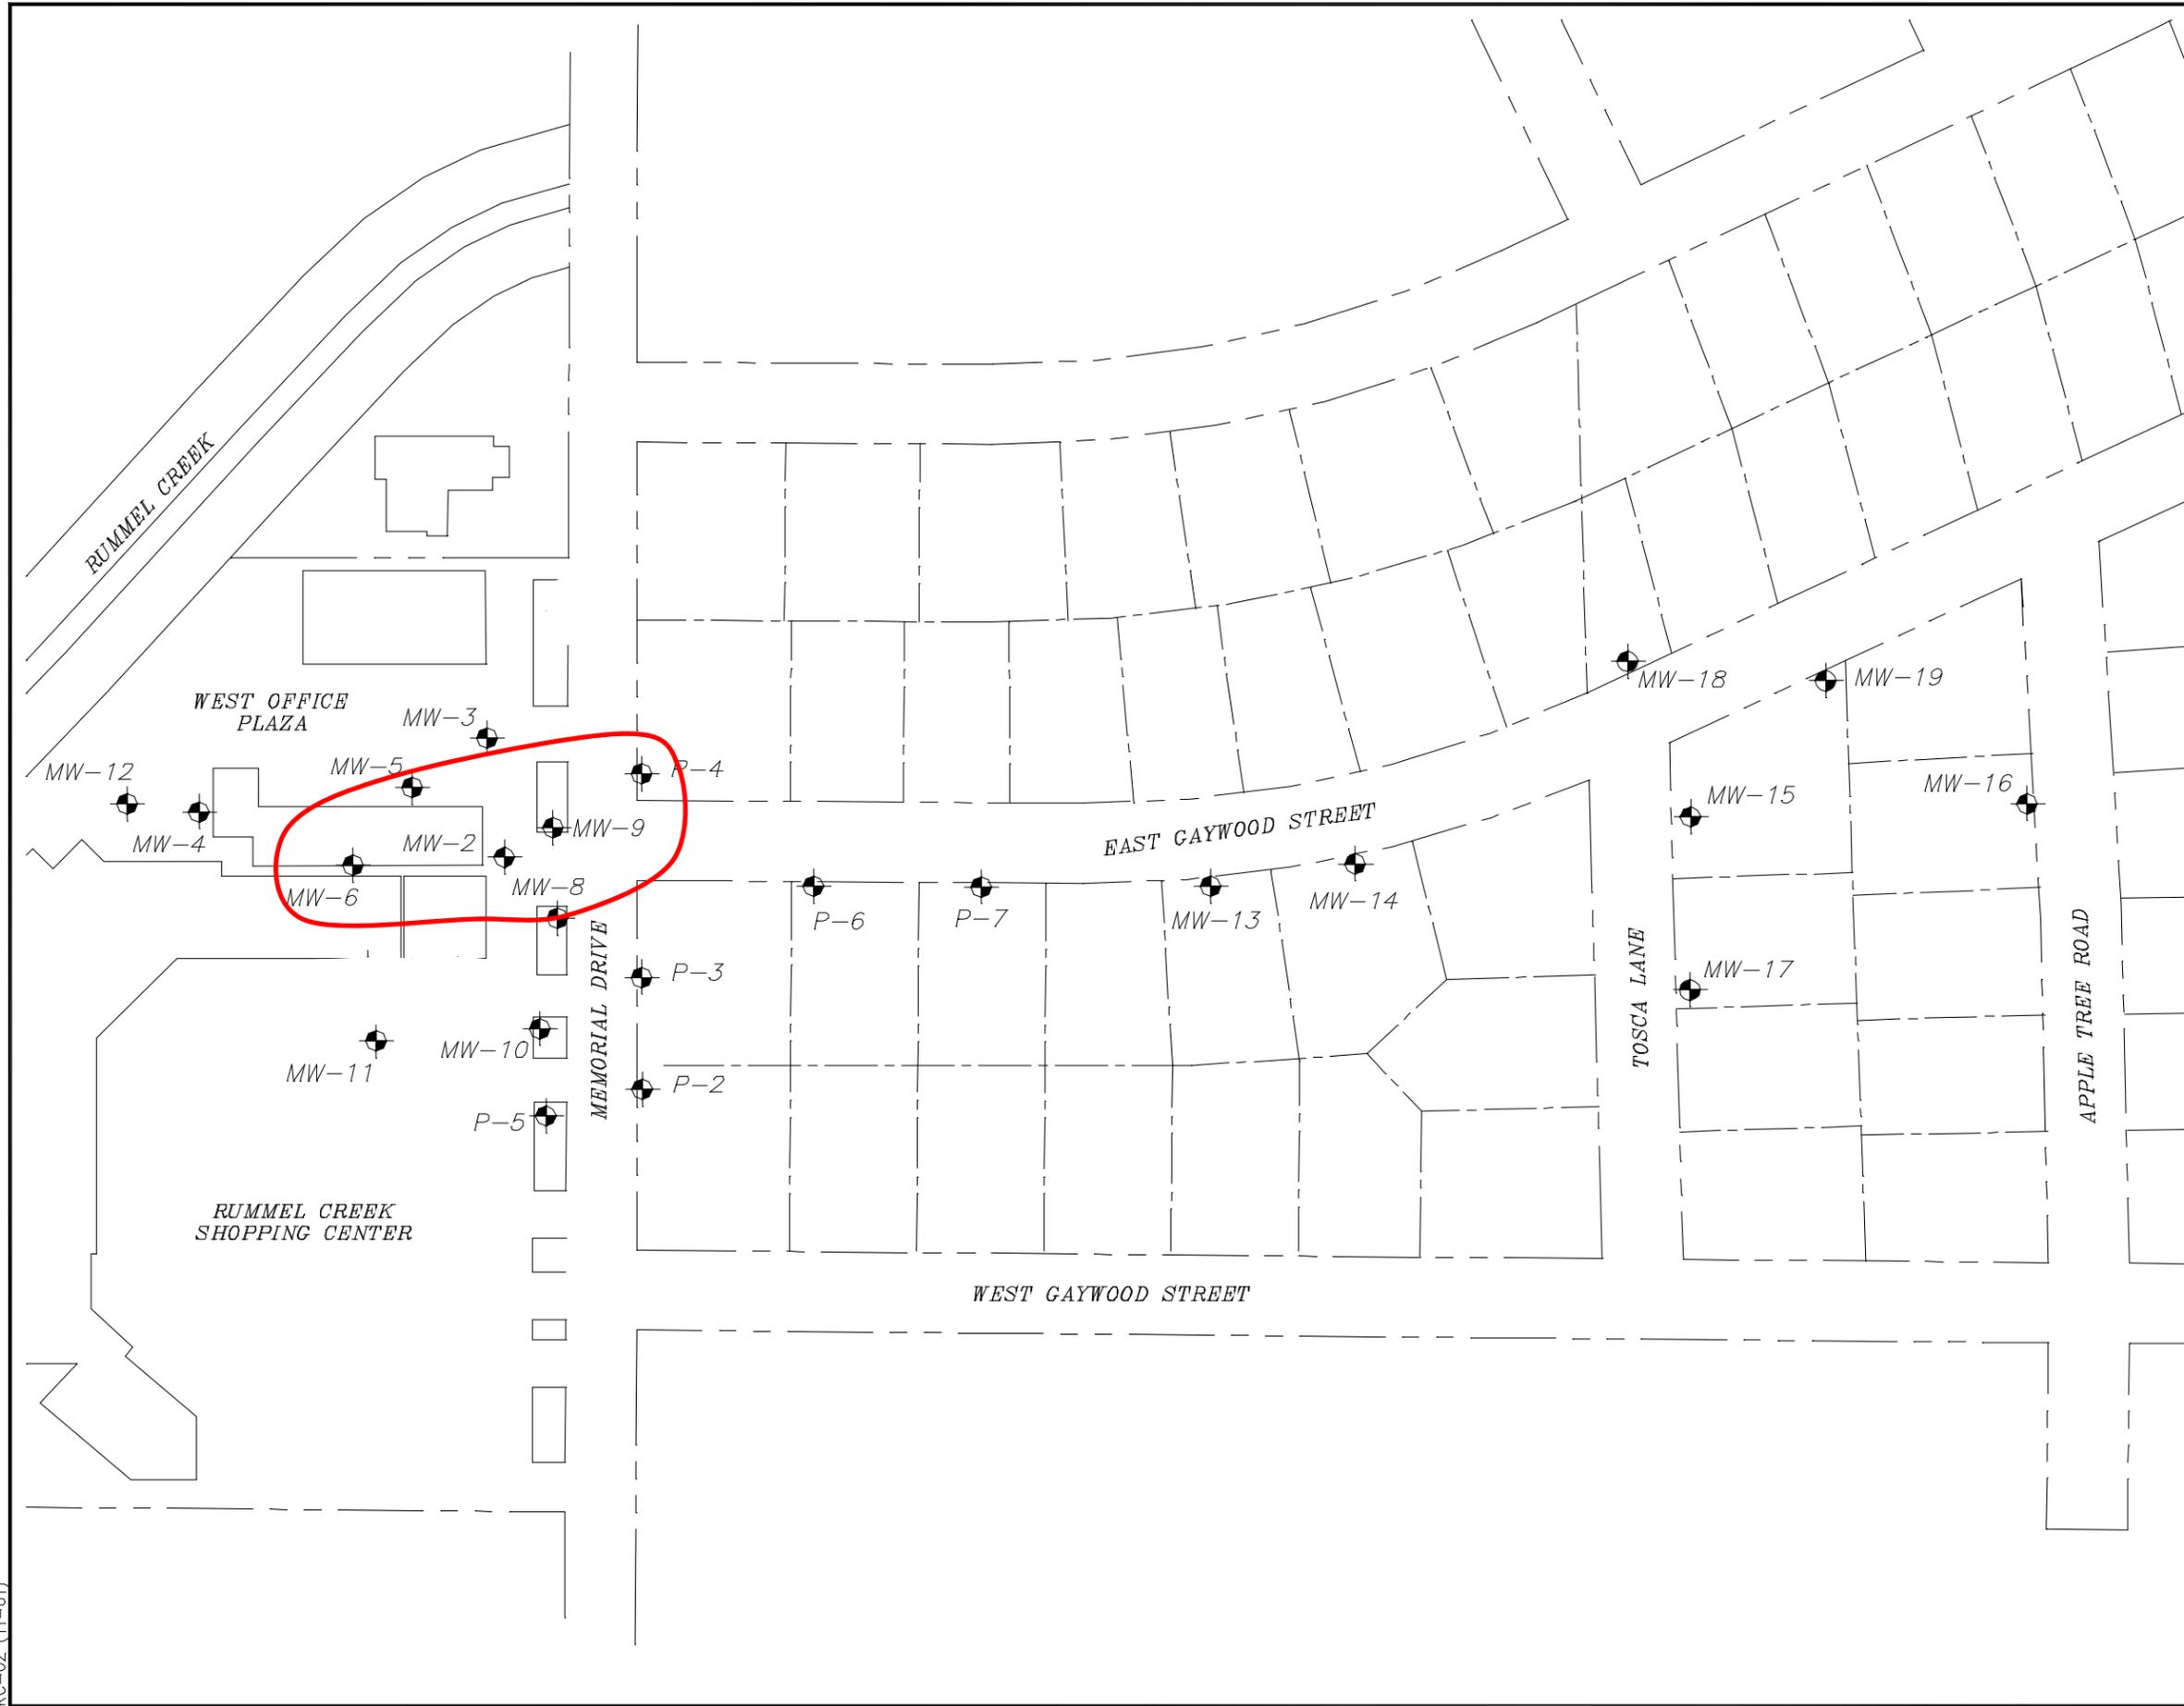
CLIENT: SRS SHOPPING CENTER HOUSTON, TEXAS		P.N.: JB	
LOCATION: HOUSTON, TEXAS		CHECKED:	
DETAILED: 4/9/08	DESIGNED:	PROJECT NO: 123-102	FIGURE: 4B

Groundwater PCLE Zone

A review of the most recent groundwater sampling data (March 2008) indicates that PCE, TCE, cis-1,2-DCE and VC currently exceed the Tier 1 ^{GW}GW_{ing} PCLs in a small portion of the original plume area. The most recent groundwater sampling data indicates that the PCL exceedence (PCLE) zone extends from the subject property south across Memorial Drive to the first residence at the intersection with East Gaywood Street (**Figure 4B**).

A) A review of recent groundwater sampling data (March 2008) indicates that the COCs that currently exceed the Tier 1 ^{GW}GW_{ing} PCLs are tetrachloroethene (PCE), trichloroethene (TCE) cis-1,2-dichloroethene (cis-1,2-DCE) and vinyl chloride (VC). Monitor wells located on the surrounding properties indicate the groundwater PCLE zone extends off-site to the south. The area of groundwater impact is delineated in all directions (**Figure 4B**).

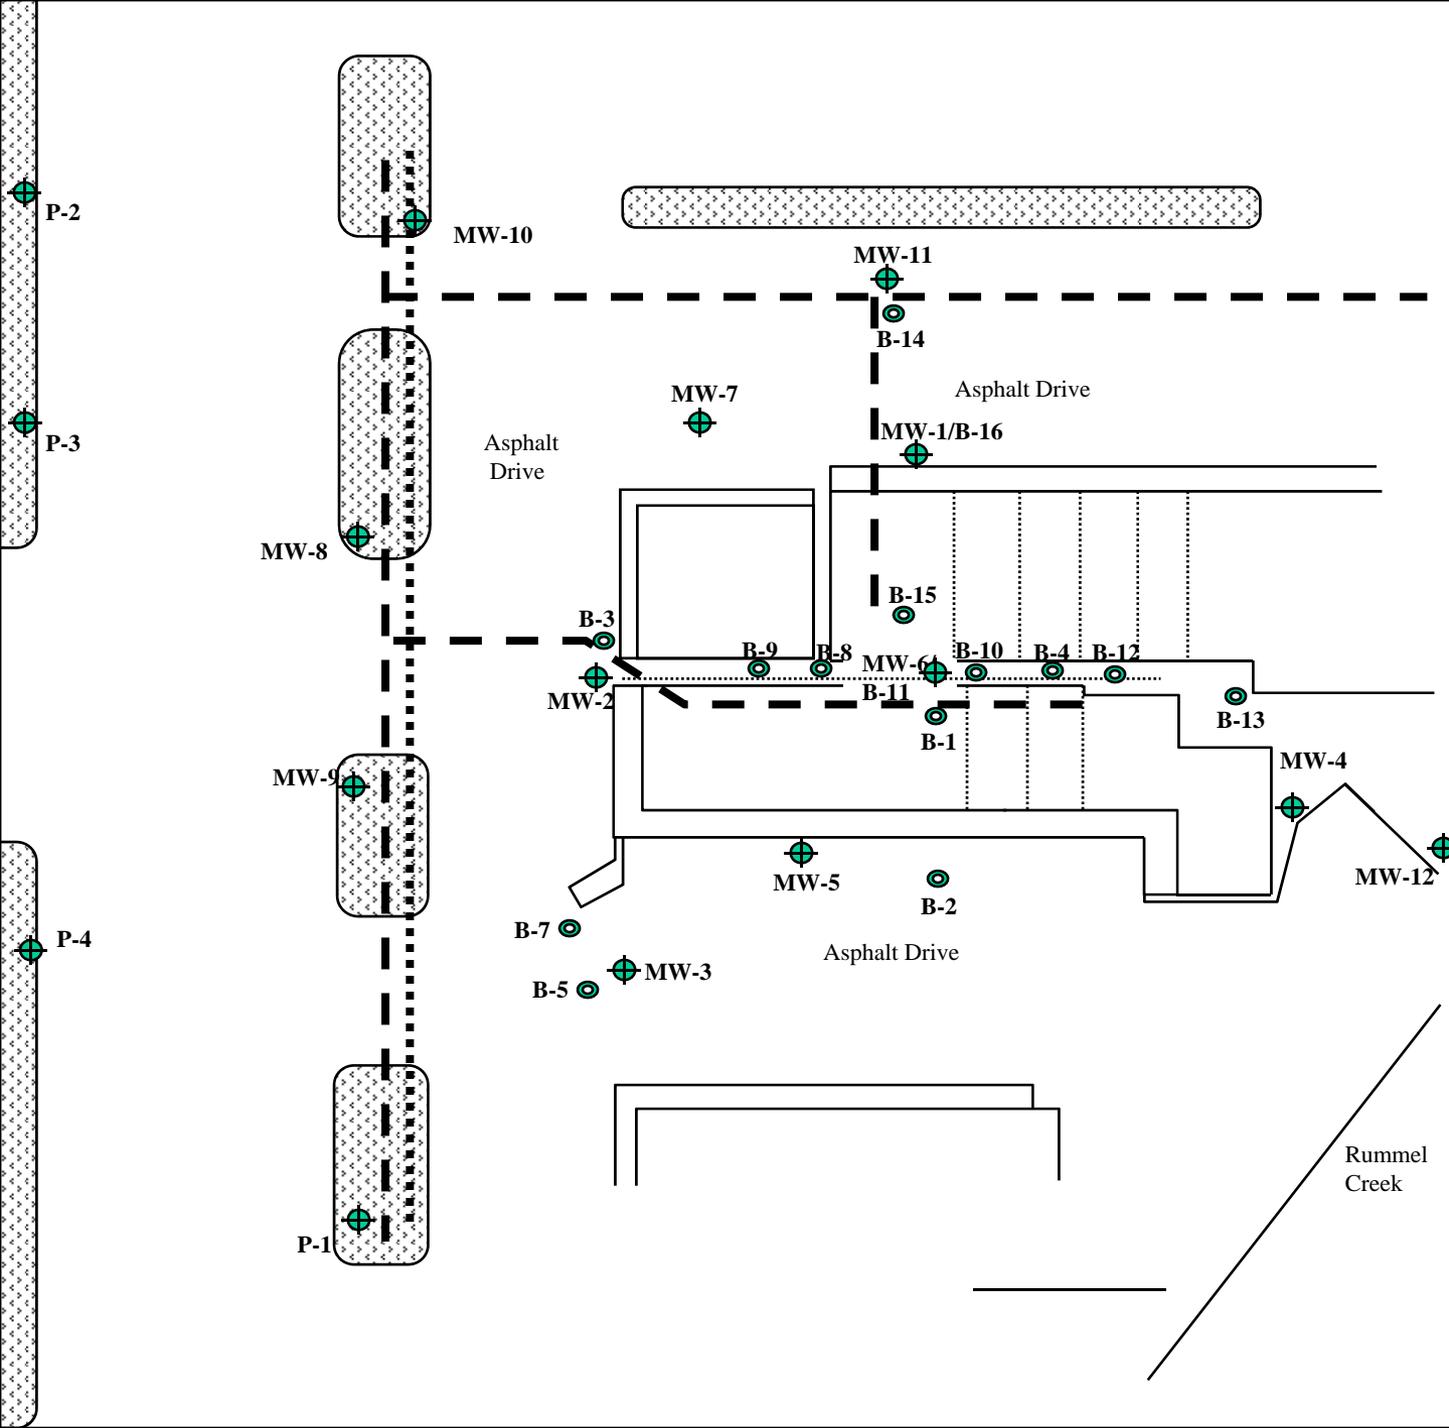
CLIENT:		SRS Shopping Centers, Ltd.		PM:	JB
LOCATION:		Memorial Drive Houston, Texas		CHECKED:	
DETAILED:	DESIGNED:	PROJECT NO.:	FIGURE:		
6/25/02	JB		5B-1

- Soil Boring Location
- Groundwater Monitoring Well
- Sanitary Sewer Line
- Storm Water Sewer Lines
- Abandoned Sewer Line

Soil Boring Locations

Figure 5B-1 – Soil Sampling Locations

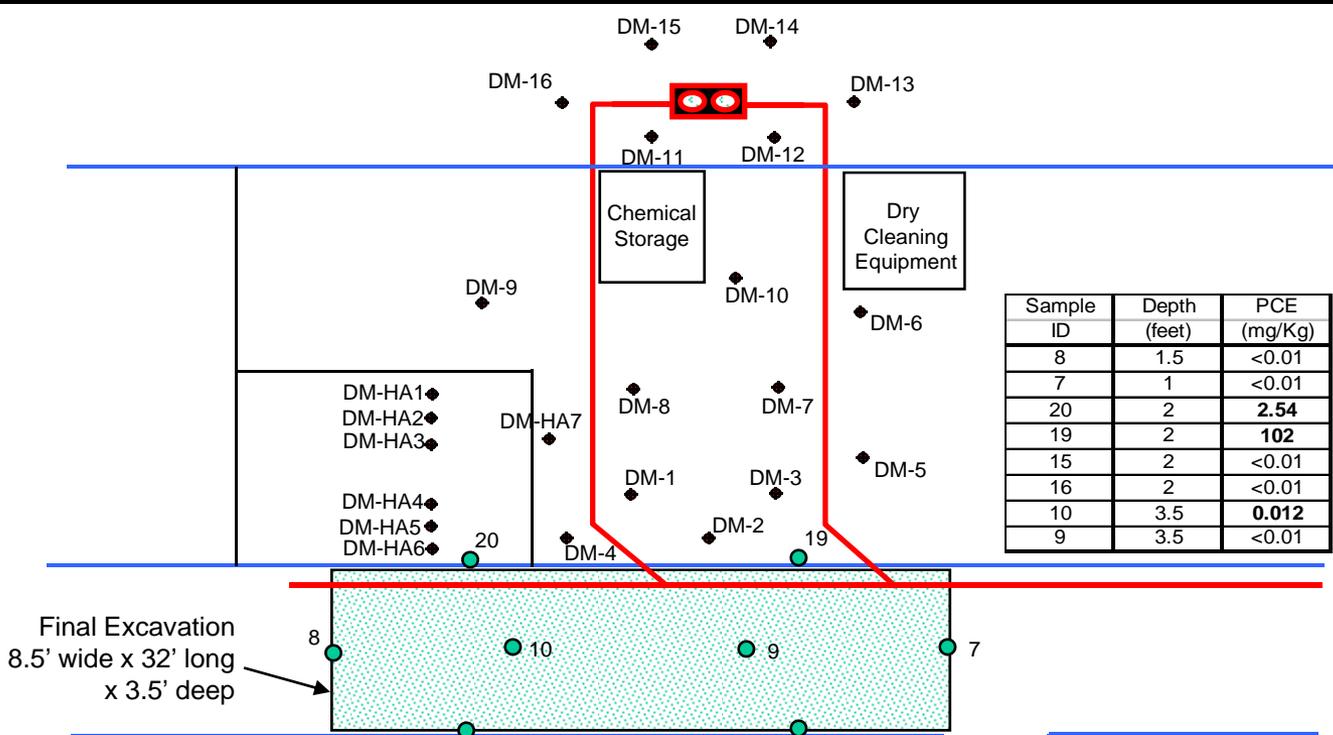
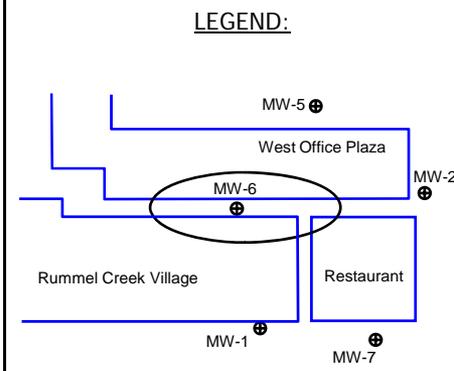
CLIENT:	SRS Shopping Centers, Ltd.	PM:	JB
LOCATION:	Memorial Drive Houston, Texas	CHECKED:	
DETAILED:	7/28/03	DESIGNED:	JB
PROJECT NO.:		FIGURE:	5B-2

Sample ID	Depth (feet)	PCE (mg/Kg)
8	1.5	<0.01
7	1	<0.01
20	2	2.54
19	2	102
15	2	<0.01
16	2	<0.01
10	3.5	0.012
9	3.5	<0.01

Sample ID	Depth (feet)	PCE (mg/Kg)
DM-1	4-5	0.051
DM-2	4-5	0.026
DM-2	8-9	0.036
DM-3	0-1	0.0066
DM-3	1-2	0.067
DM-3	2-3	0.020
DM-3	3-4	0.027
DM-3	4-5	0.018
DM-3	5-6	0.018
DM-3	6-7	0.014
DM-3	7-8	0.0039
DM-3	8-9	0.042
DM-4	4-5	0.017
DM-4	8-9	0.023
DM-5	4-5	0.012
DM-5	8-9	0.029
DM-6	4-5	0.0058
DM-6	8-9	0.0056
DM-7	4-5	0.0084
DM-7	8-9	0.018
DM-8	4-5	0.056
DM-8	8-9	0.026

Sample ID	Depth (feet)	PCE (mg/Kg)
DM-9	4-5	0.0049
DM-9	8-9	0.0047
DM-10	0-1	0.067
DM-10	3-4	0.018
DM-10	5-6	<0.001
DM-10	8-9	0.004
DM-11	2-3	<0.001
DM-11	4-5	<0.001
DM-11	6-7	<0.001
DM-11	8-9	<0.001
DM-12	2-3	<0.001
DM-12	6-7	<0.001
DM-12	8-9	<0.001
DM-13	2-3	<0.001
DM-13	6-7	<0.001
DM-13	8-9	<0.001
DM-14	2-3	<0.001
DM-14	6-7	<0.001
DM-14	8-9	<0.001

Sample ID	Depth (feet)	PCE (mg/Kg)
DM-15	2-3	<0.001
DM-15	6-7	<0.001
DM-15	8-9	<0.001
DM-16	2-3	<0.001
DM-16	6-7	<0.001
DM-16	8-9	<0.001
DMHA1	1-2	0.013
DMHA2	4-5	0.0025
DMHA2	5-6	<0.001
DMHA3	2-3	0.015
DMHA3	4-5	0.0034
DMHA4	1-2	0.013
DMHA4	5-6	0.0073
DMHA5	2-3	0.0033
DMHA5	4-5	0.0034
DMHA6	2-3	0.011
DMHA6	4-5	<0.001
DMHA7	2-3	0.044
DMHA7	4-5	0.020

Soil Sampling Locations and Results

Figure 5B-2 – Soil Sampling Locations

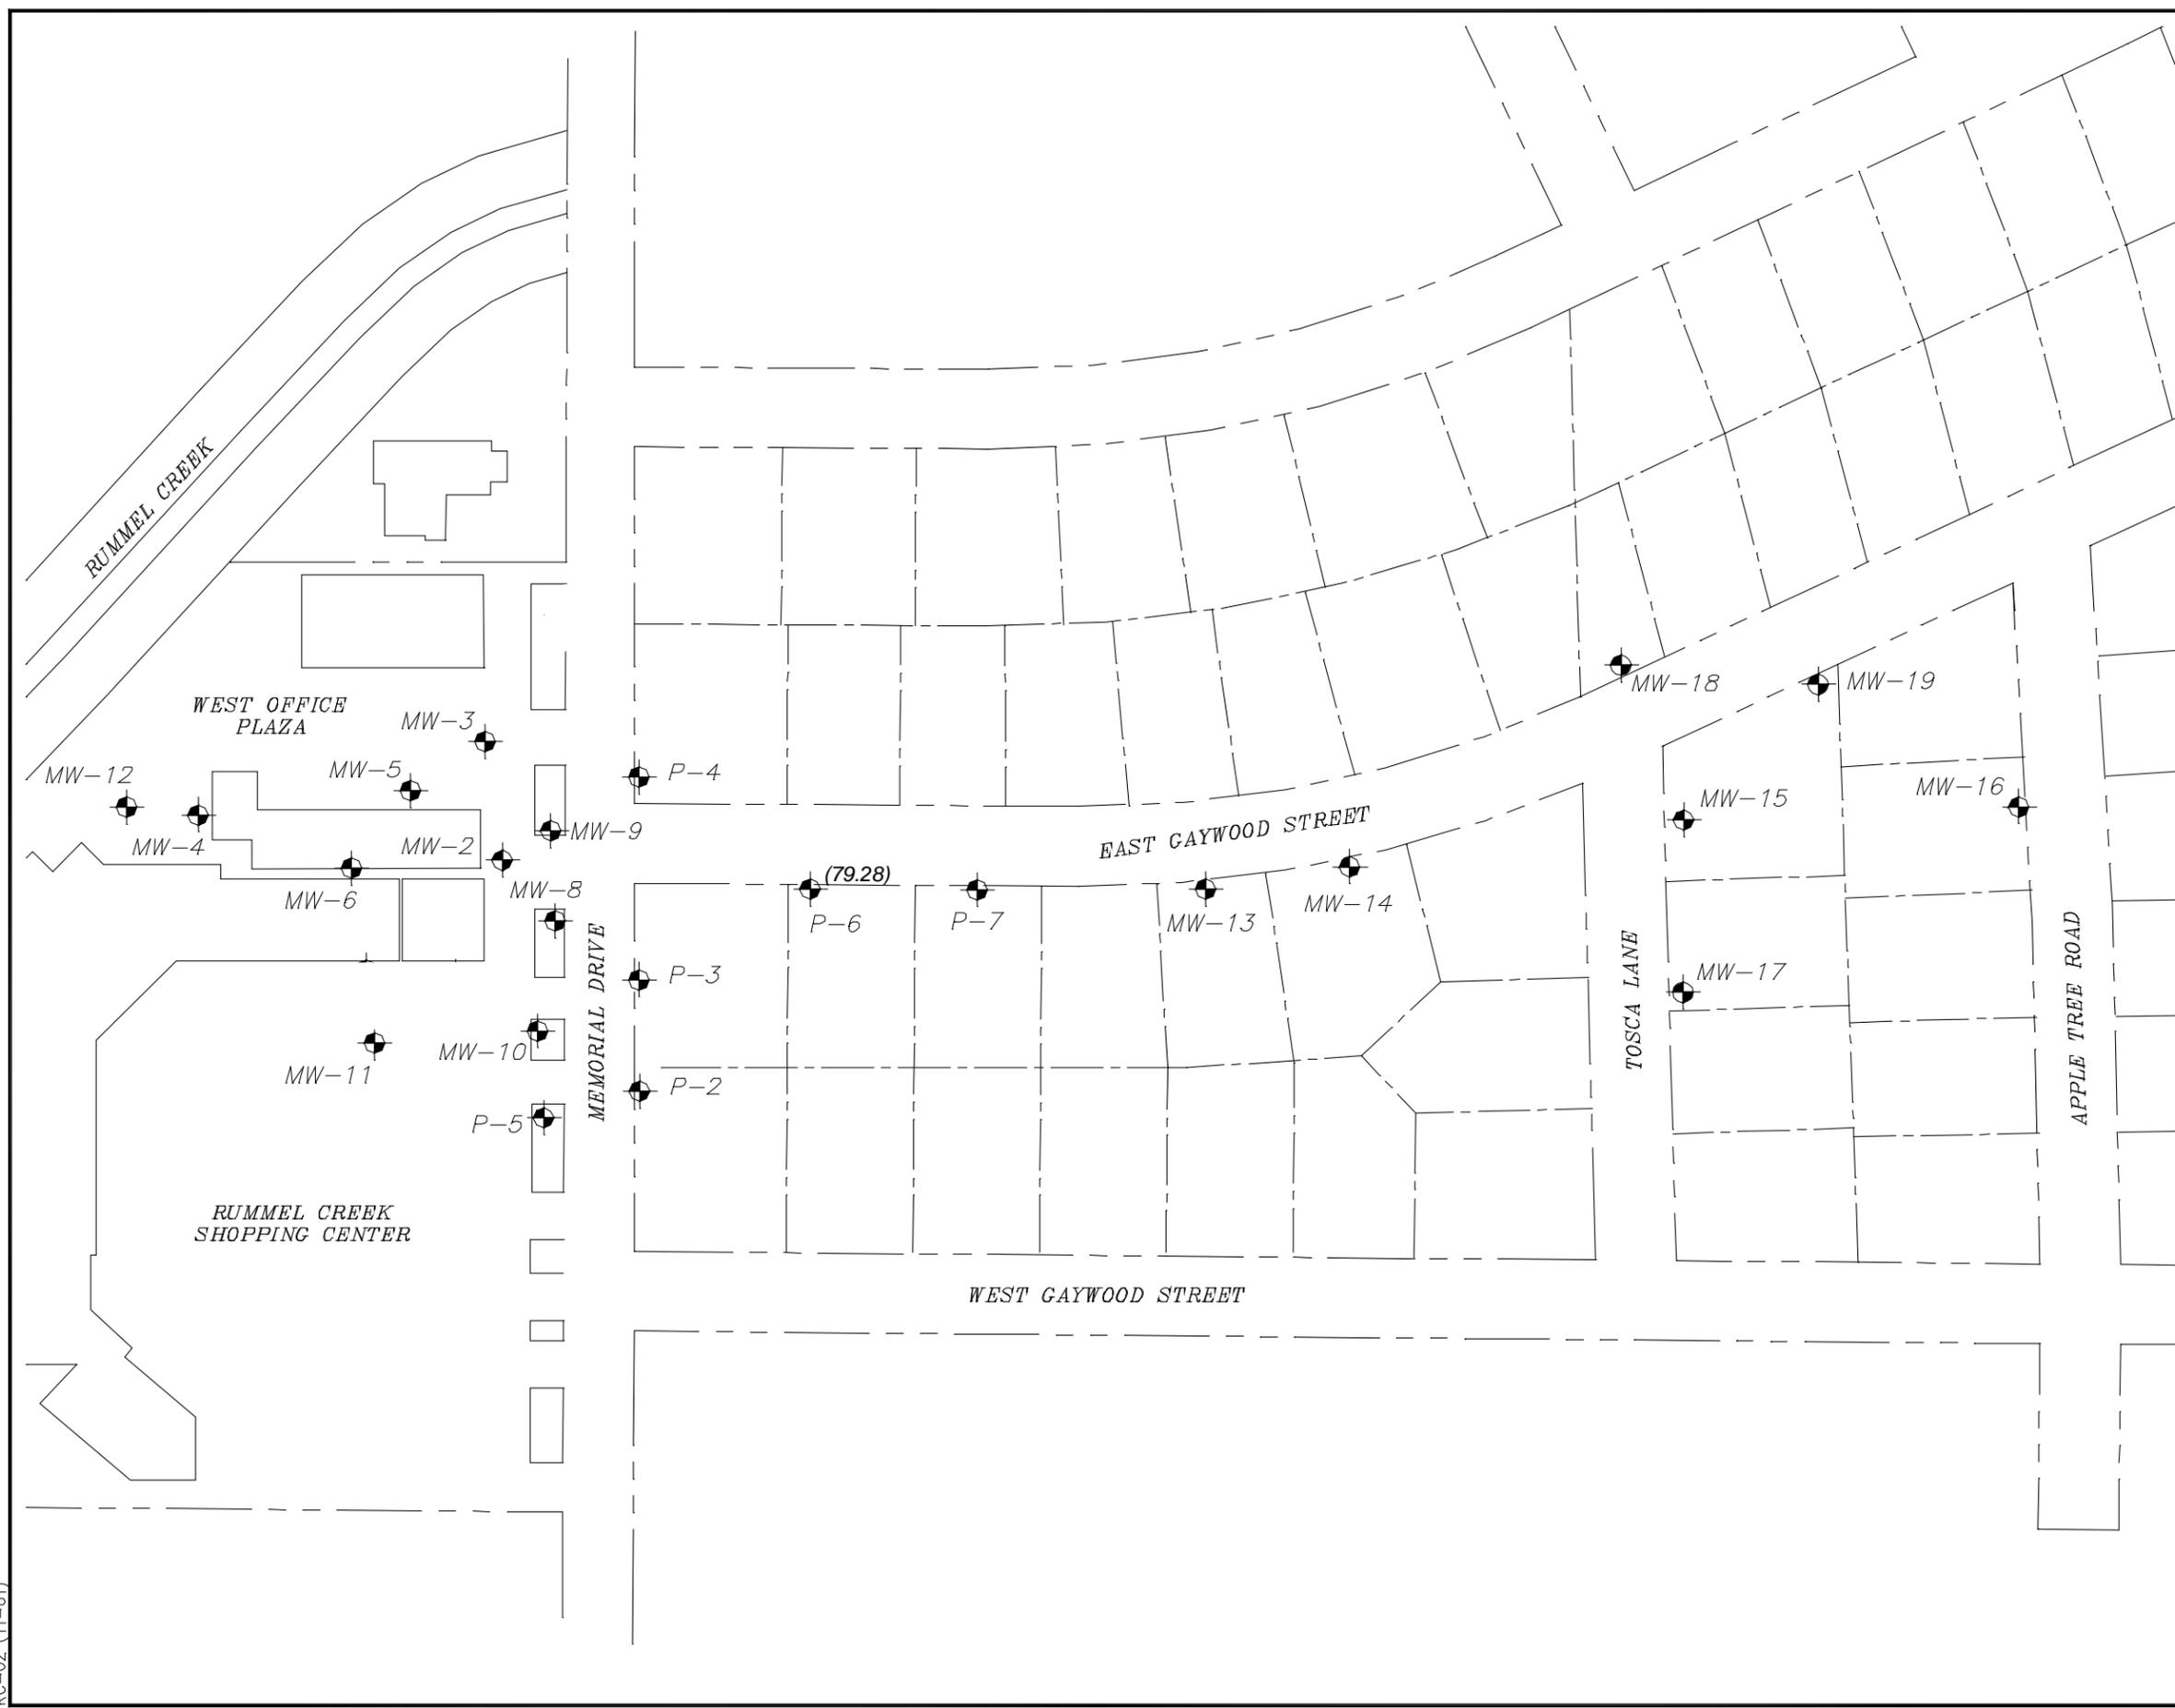
CLIENT: SRS SHOPPING CENTER HOUSTON, TEXAS		P.N.: JB	
LOCATION: HOUSTON, TEXAS		CHECKED:	
DETAILED: 12/10/07	DESIGNED:	PROJECT NO: 123-102	FIGURE: 6B

Groundwater Sampling Locations

Figure 6B – Groundwater Sampling Locations

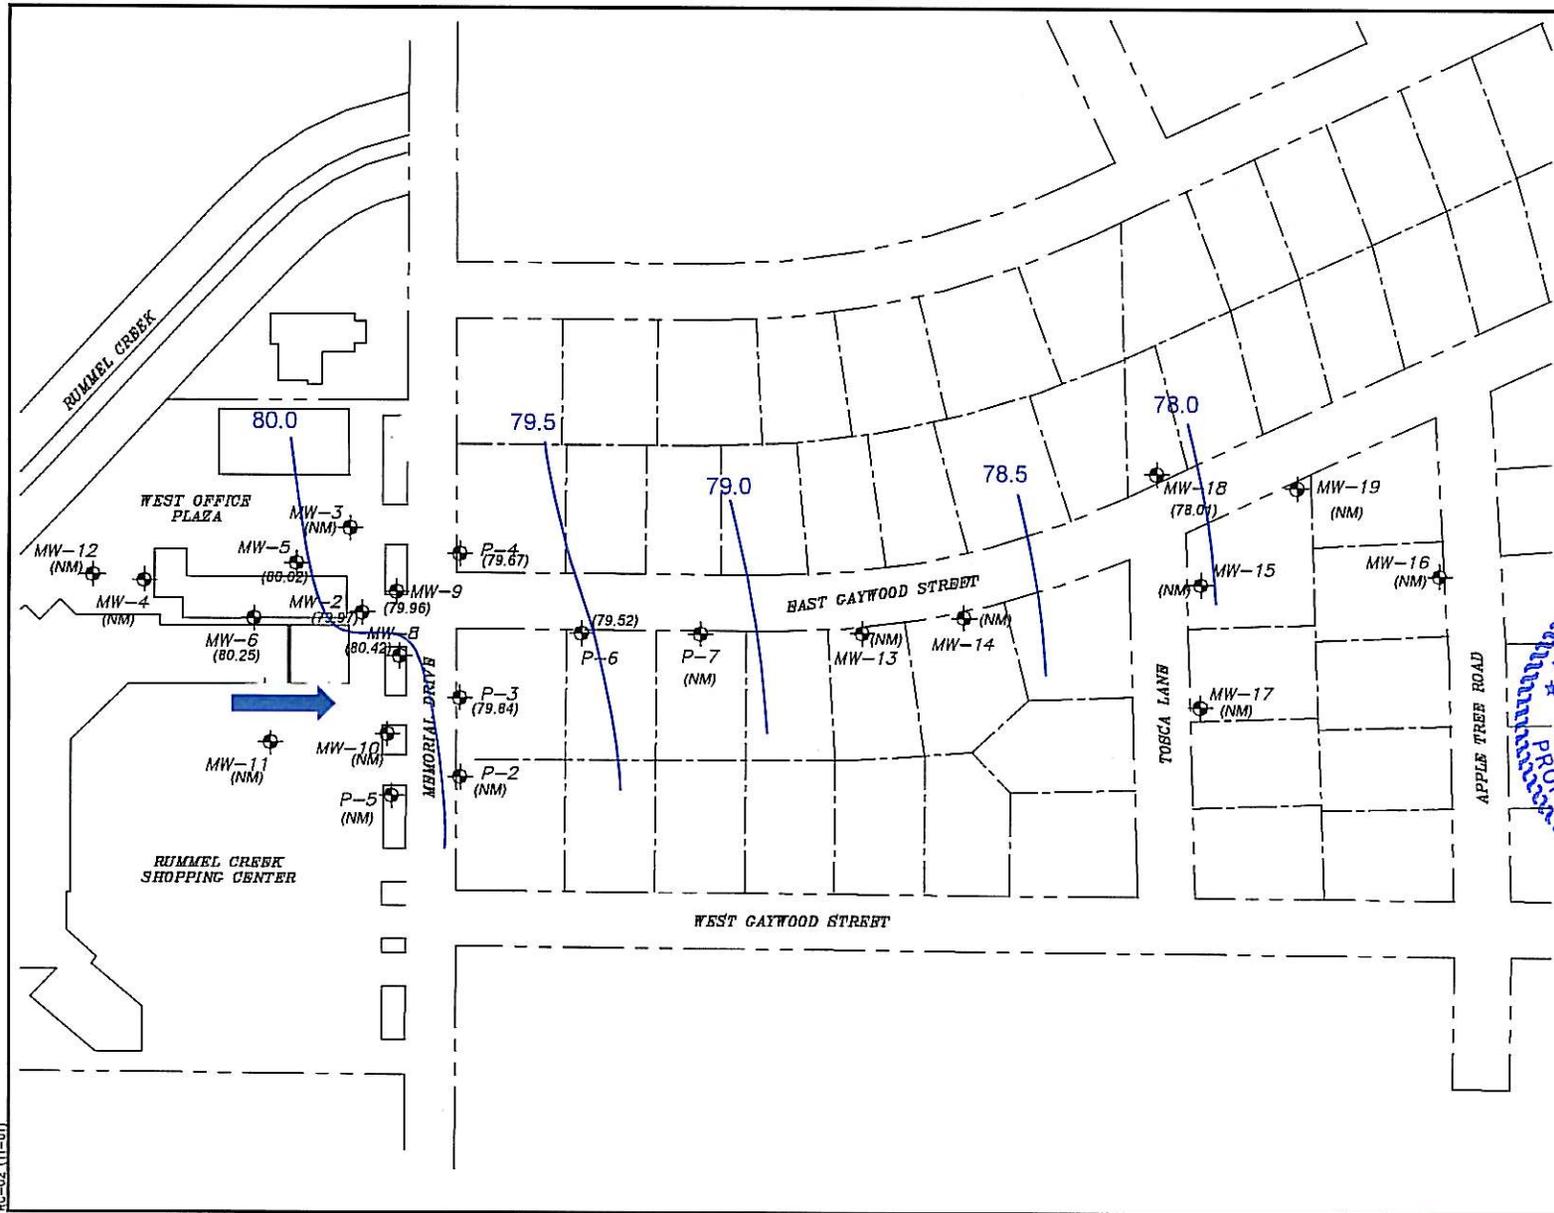
CLIENT	SRS SHOPPING CENTER HOUSTON, TEXAS	P.L.	JB
LOCATION	HOUSTON, TEXAS	CHECKED	
DATE	12/10/07	PROJECT NO.	123-102
		SCALE	7B

Potentiometric Surface Map
 March 2008

Figure 7B – Groundwater Gradient Map (March 2008)

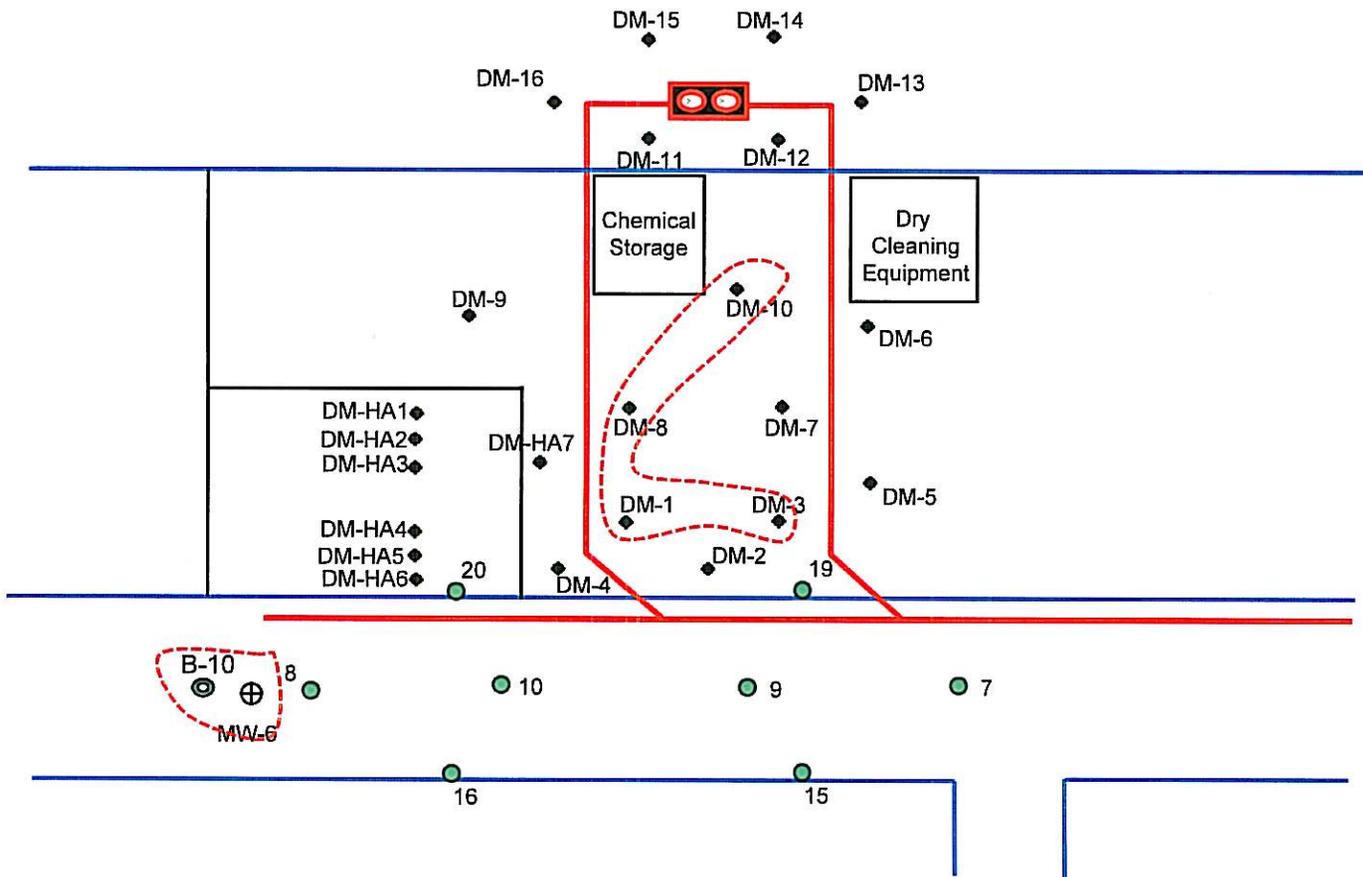
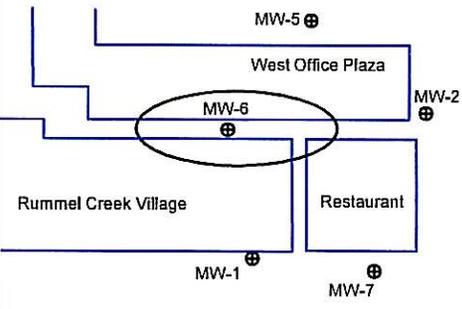
InControl Technologies, Inc.			
3845 FM 1960 W, Suite 195 Houston, Texas 77068 (281) 580-8892 FAX (281) 580-8853			
Soil PCLE Zone Map			
CLIENT:		PM:	
SRS Shopping Centers, Ltd.		JB	
LOCATION:		CHECKED:	
Memorial Drive Houston, Texas			
DETAILED:	DESIGNED:	PROJECT NO:	FIGURE:
7/28/03	JB		8B

PCLE Zone - PCE

Figure 8B– Soil PCL Exceedence Zone Map

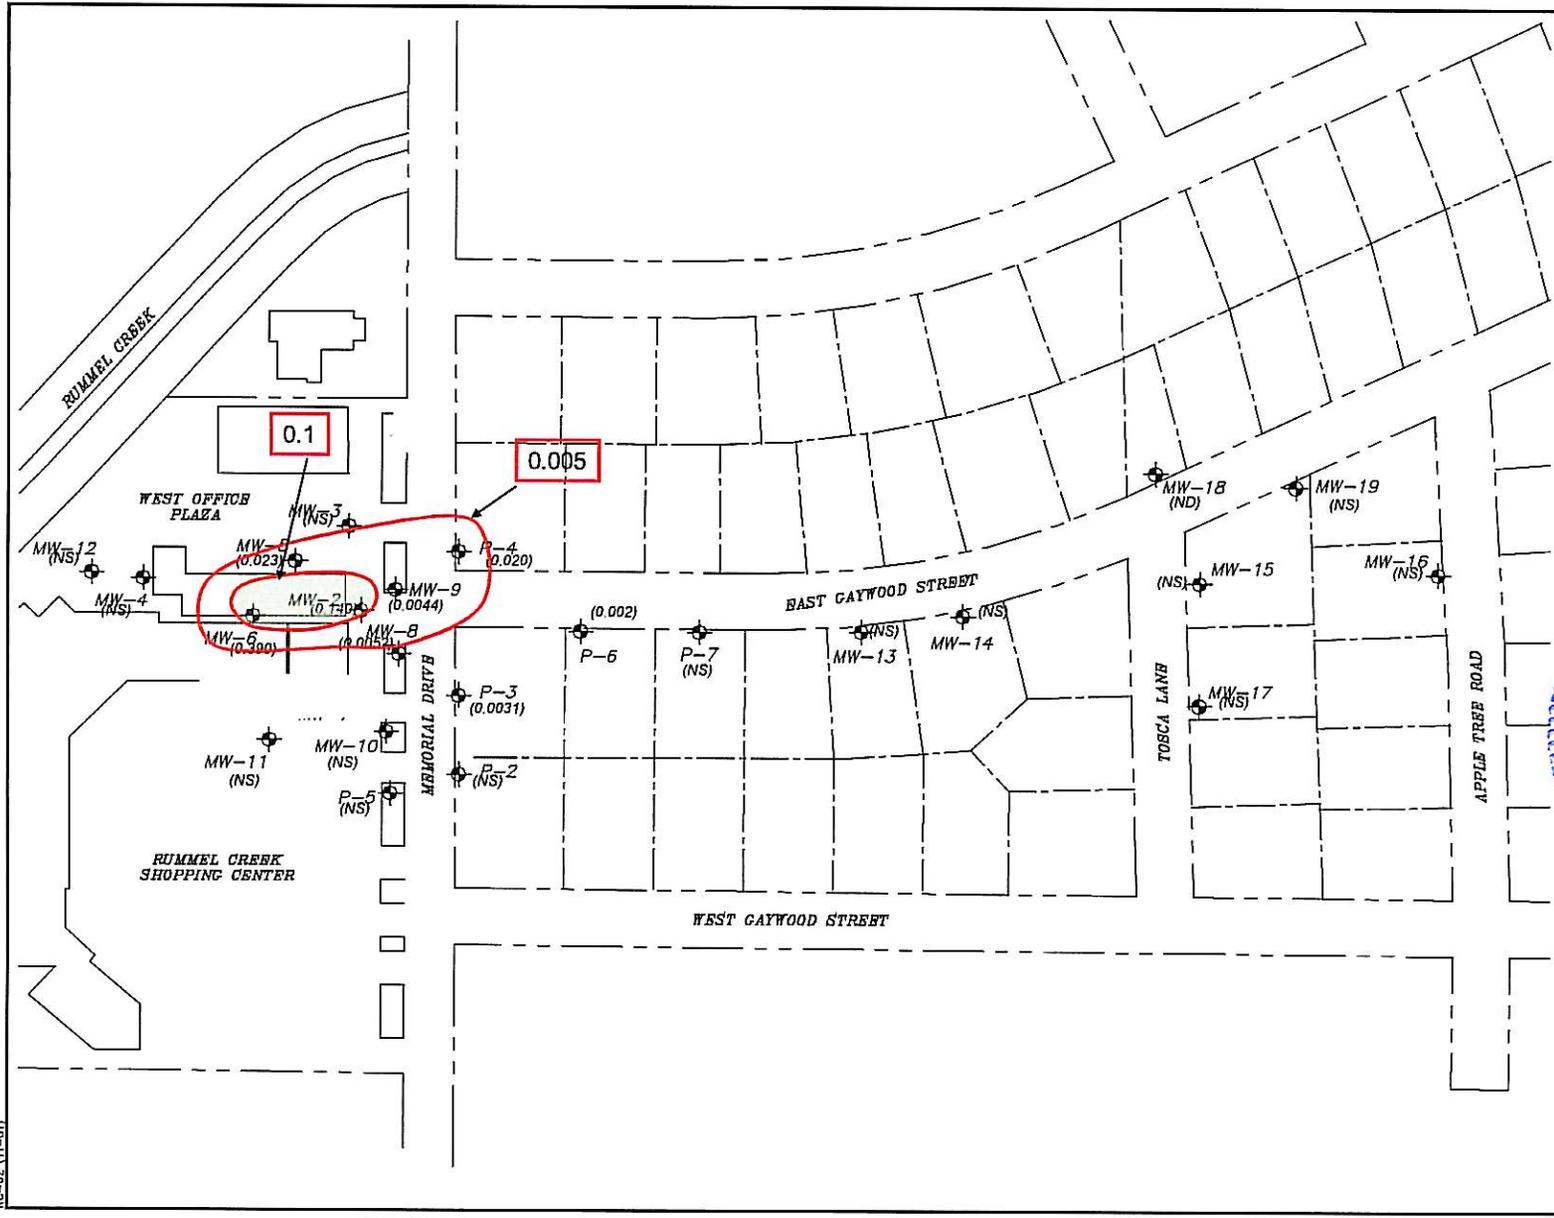
CLIENT	SRS SHOPPING CENTER HOUSTON, TEXAS	P.I.	JB
LOCATION	HOUSTON, TEXAS	CHECKED	
DATE	4/9/08	PROJECT NO.	123-102
		FILE NO.	9B-1

- LEGEND:**
- GROUNDWATER MONITORING WELL
 - (ND)* PCE Concentration (mg/L)
 - PCE Isoconcentration Contour

**PCE Concentration Map
 (March 2008)**

Figure 9B-1 – Groundwater PCL Exceedence Zone Map (PCE)

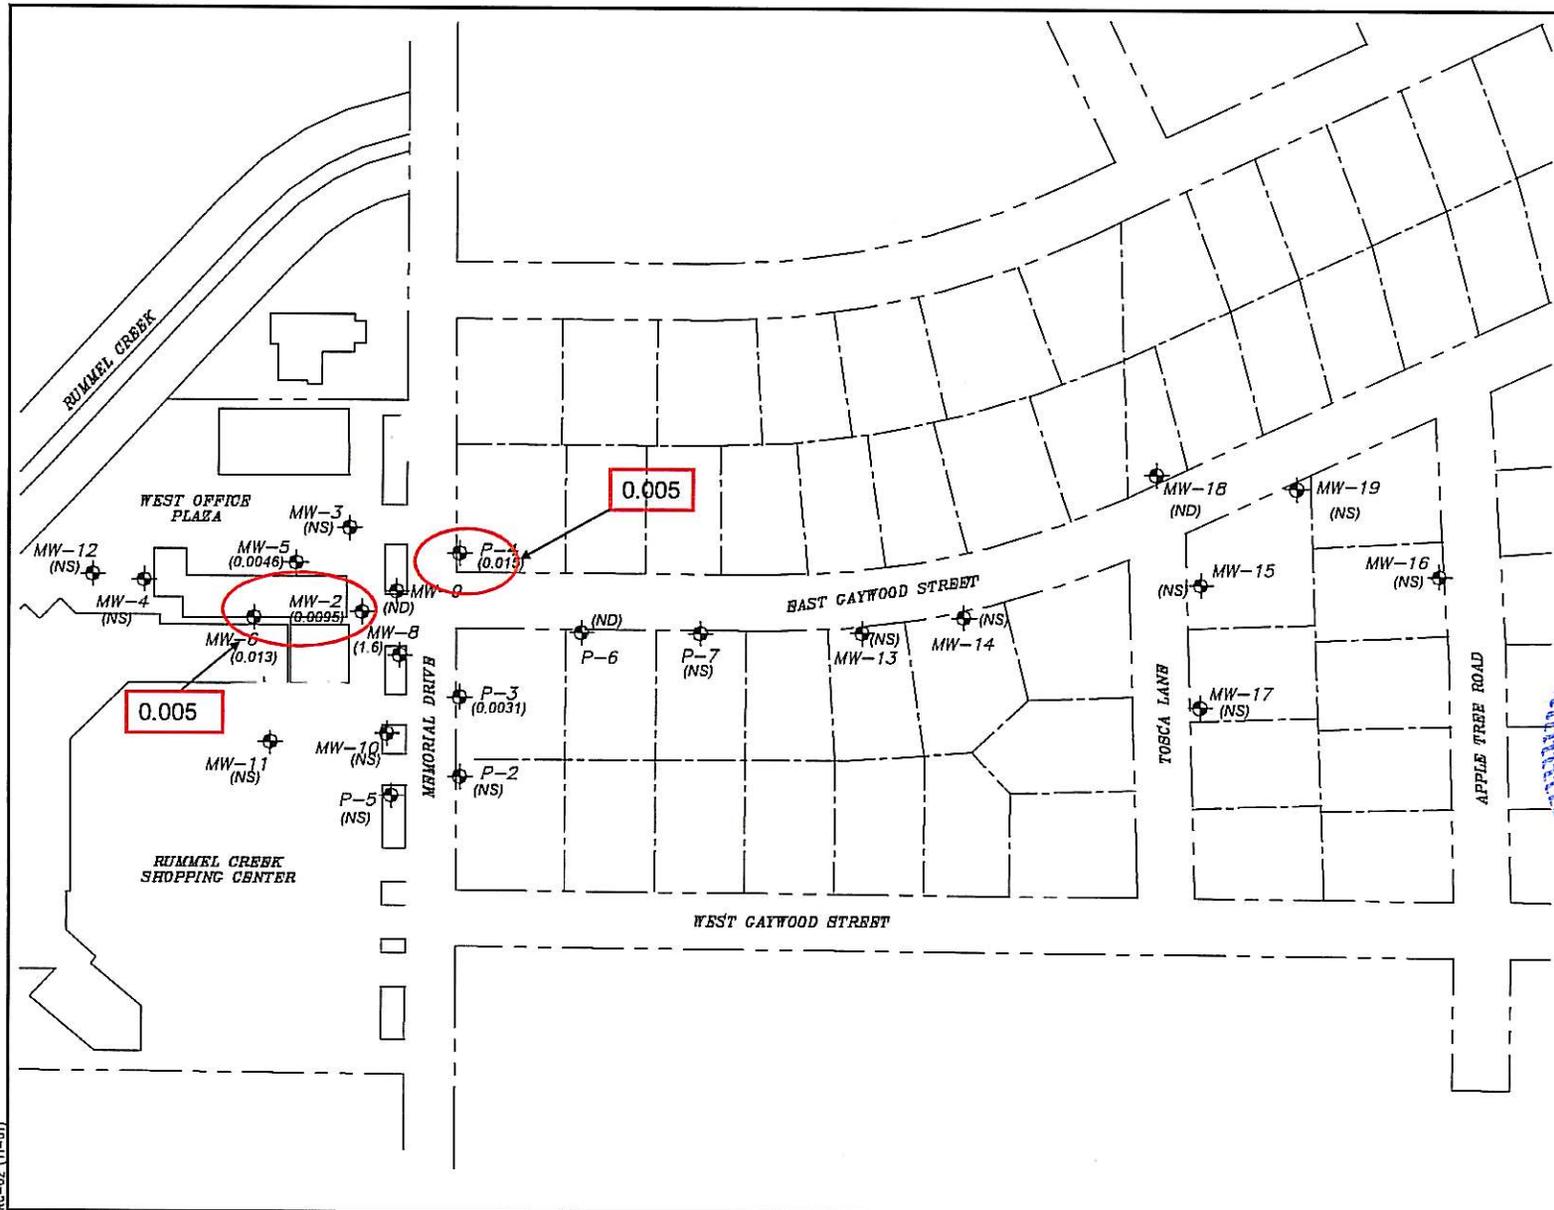
CLIENT	SRS SHOPPING CENTER HOUSTON, TEXAS	FILE	JB
LOCATION	HOUSTON, TEXAS	CREATOR	
DATE	4/9/08	PROJECT NO.	123-102
REVISION		FIGURE	9B-2

- LEGEND:**
- GROUNDWATER MONITORING WELL
 - (ND)* TCE Concentration (mg/L)
 - TCE Isoconcentration Contour

**TCE Concentration Map
 (March 2008)**

Figure 9B-2 – Groundwater PCL Exceedence Zone Map (TCE)
