CITY OF HOUSTON

**PUBLIC WORKS AND
ENGINEERING
PLANNING & DEVELOPMENT
DIVISION**

EXECUTIVE SUMMARY

Appendix B – Site Maps

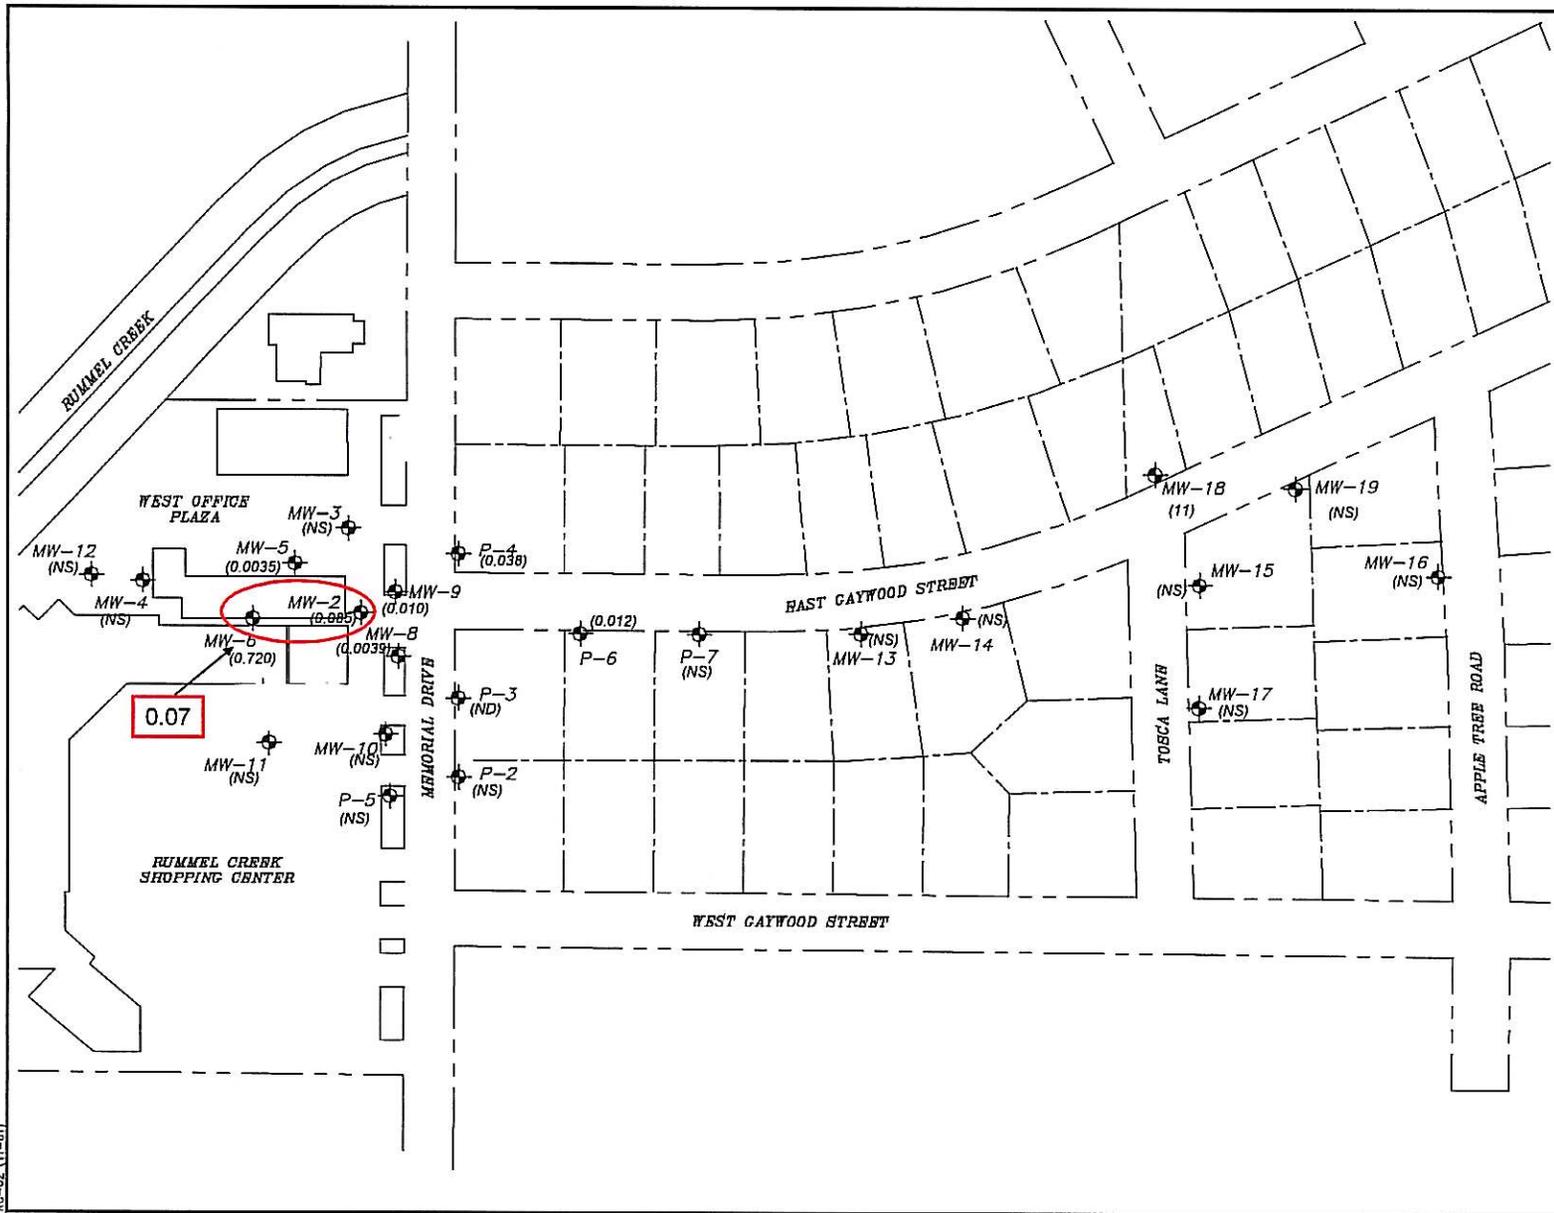
CLIENT	SRS SHOPPING CENTER HOUSTON, TEXAS	DRAWN BY	JB
LOCATION	HOUSTON, TEXAS	CHECKED BY	
DATE	4/9/08	PROJECT NO.	123-102
		FIGURE NO.	9B-3

- LEGEND:**
- GROUNDWATER MONITORING WELL
 - (ND)* cis-1,2-DCE Concentration (mg/L)
 - Cis-1,2-DCE Isoconcentration Contour

Cis-1,2-DCE Concentration Map (March 2008)

Figure 9B-3 – Groundwater PCL Exceedence Zone Map (cis-1,2-DCE)

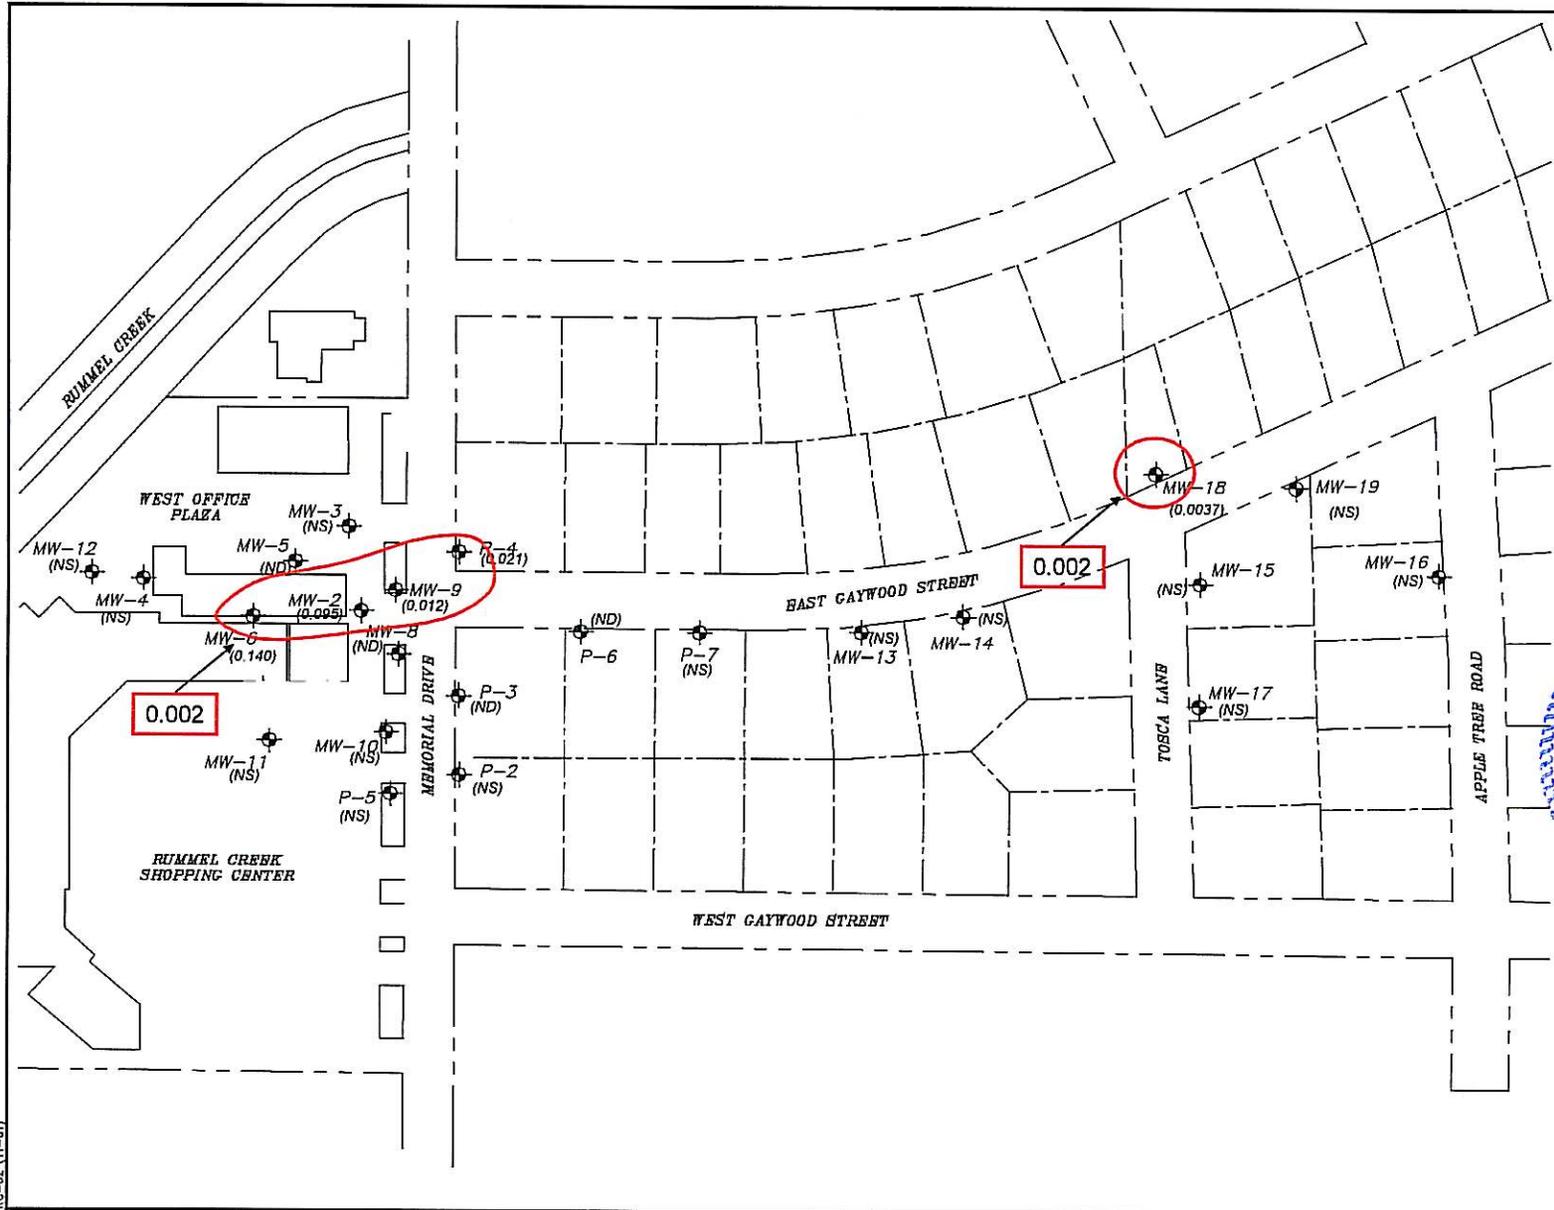
CLIENT:	SRS SHOPPING CENTER HOUSTON, TEXAS	P.L.:	JB
LOCATION:	HOUSTON, TEXAS	CHECKED:	
DATE:	4/9/08	PROJECT NO.:	123-102
		FIGURE NO.:	9B-4

(ND) VC Concentration (mg/L)

— VC Isoconcentration Contour

**VC Concentration Map
 (March 2008)**

Figure 9B-4 – Groundwater PCL Exceedence Zone Map (VC)

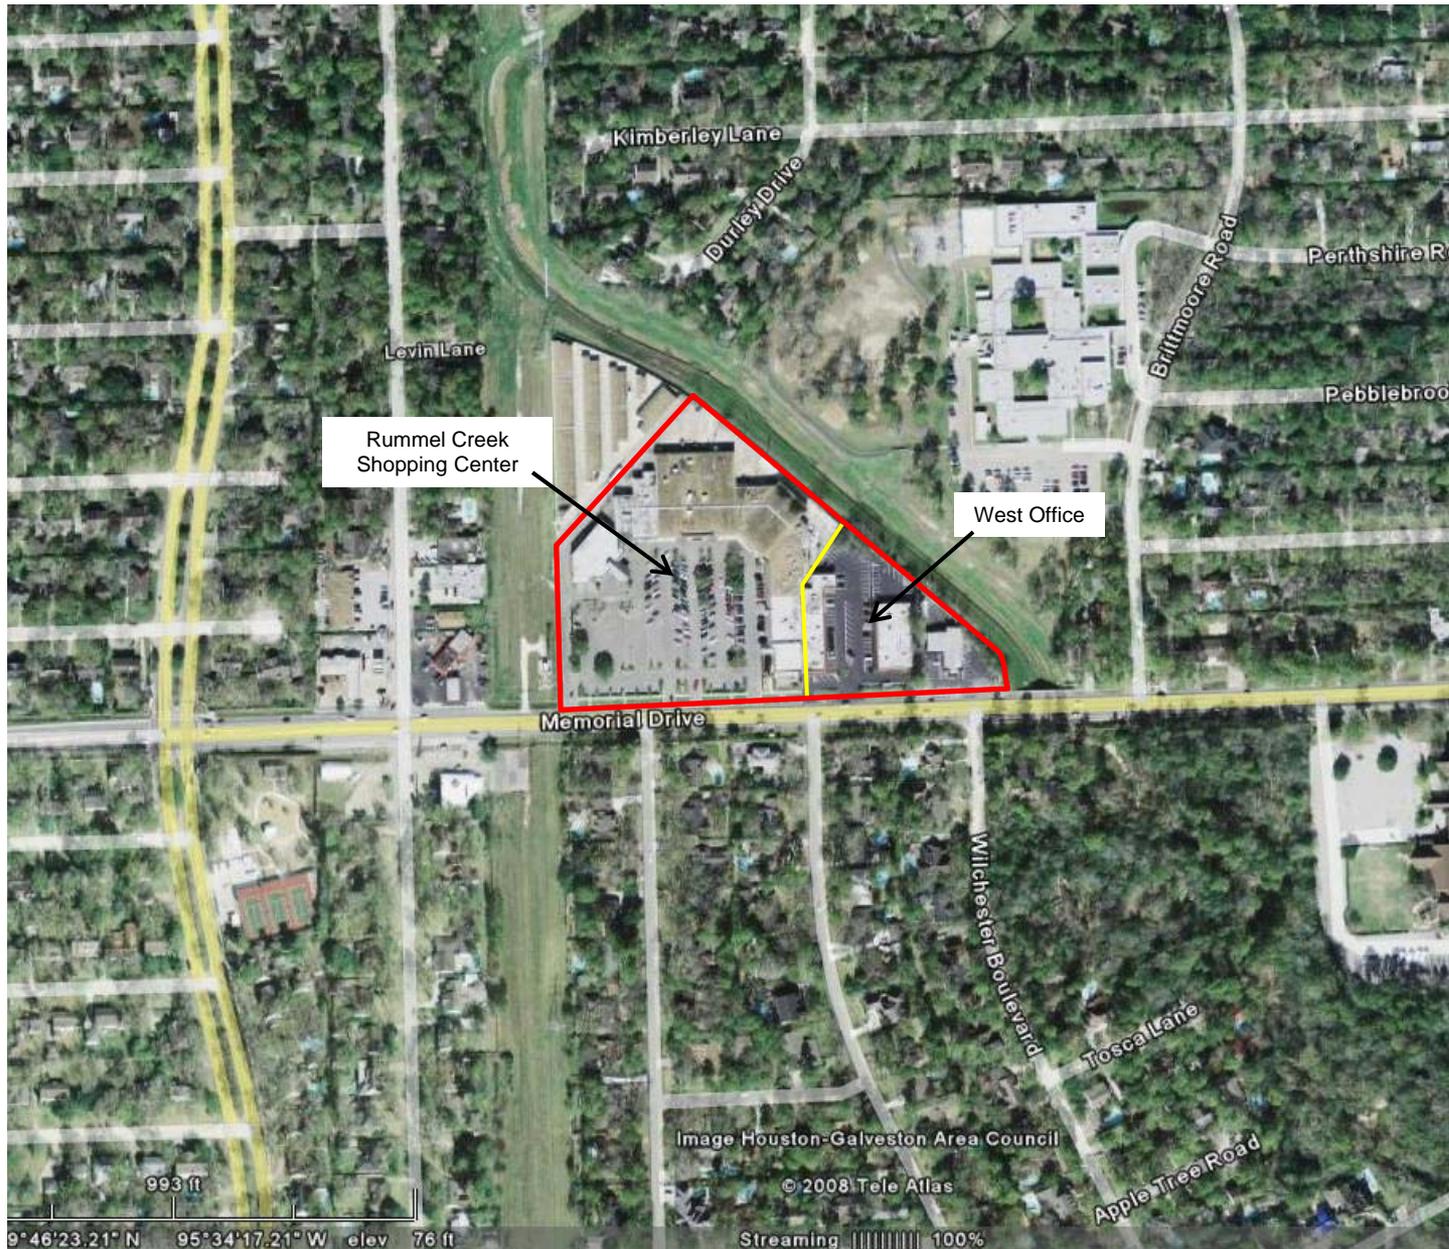
CLIENT: SRS Shopping Centers, Ltd.		PM: JB
LOCATION: Memorial Drive Houston, Texas		CHECKED:
DETAILED: 6/25/02	DESIGNED: JB	PROJECT NO:
		FIGURE: 1C

Figure 1C (found in **Appendix C**) provides a description of the surrounding land use within 500-feet of the site.

- North - The Site is bounded to the north by Rummel Creek followed by residential development.
- East - The Site is bounded to the east by Rummel Creek followed by residential development.
- South – The Site is bounded to the south by Memorial Drive followed by residential development.
- West – The Site is bounded to the west by a utility easement followed by commercial development.

Proposed MSD Boundary

Surrounding Property Map

Approximately 90% of the subject property is covered with parking spaces, walkways and retail space (**Figure 1C**). The remaining 10% is covered with decorative landscaped areas. Future use of the subject property is anticipated to remain commercial.
